INDOOR AIR QUALITY ASSESSMENT

**McKay Elementary School
McKay Street
Beverly, Massachusetts**

Prepared by:
Massachusetts Department of Public Health
Bureau of Environmental Health Assessment
Emergency Response/Indoor Air Quality Program
January 2003

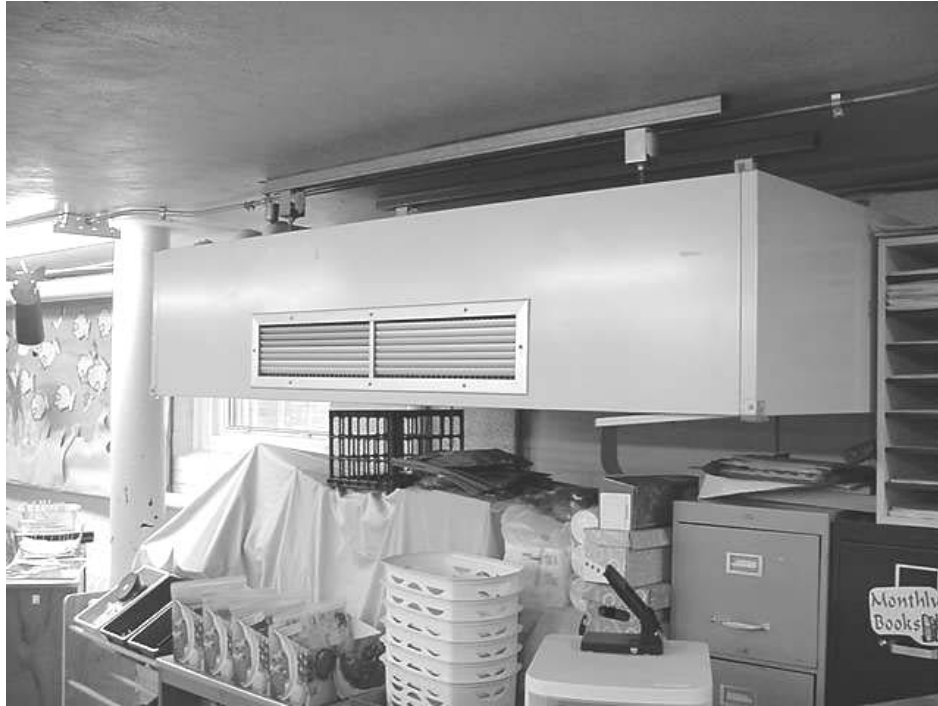
Picture 1

Classrooms in the basement floor were created from a large space that was formerly the school cafeteria. Basement classrooms 2-O and 2-M have been retrofitted with a unit ventilator (univent) system (see [Picture 1](#)). Univents draw air from outdoors through a fresh air intake located on the exterior walls of the building (see Picture 2) and return air through an air intake located at the base of each unit. Fresh and return air are mixed, filtered, heated and provided to classrooms through a fresh air diffuser located in the top of the unit (see Figure 1). Mechanical exhaust ventilation is provided by motorized wall vents, which operate continuously (see Picture 3).

Ceiling-Mounted Univent in Classroom 2-O

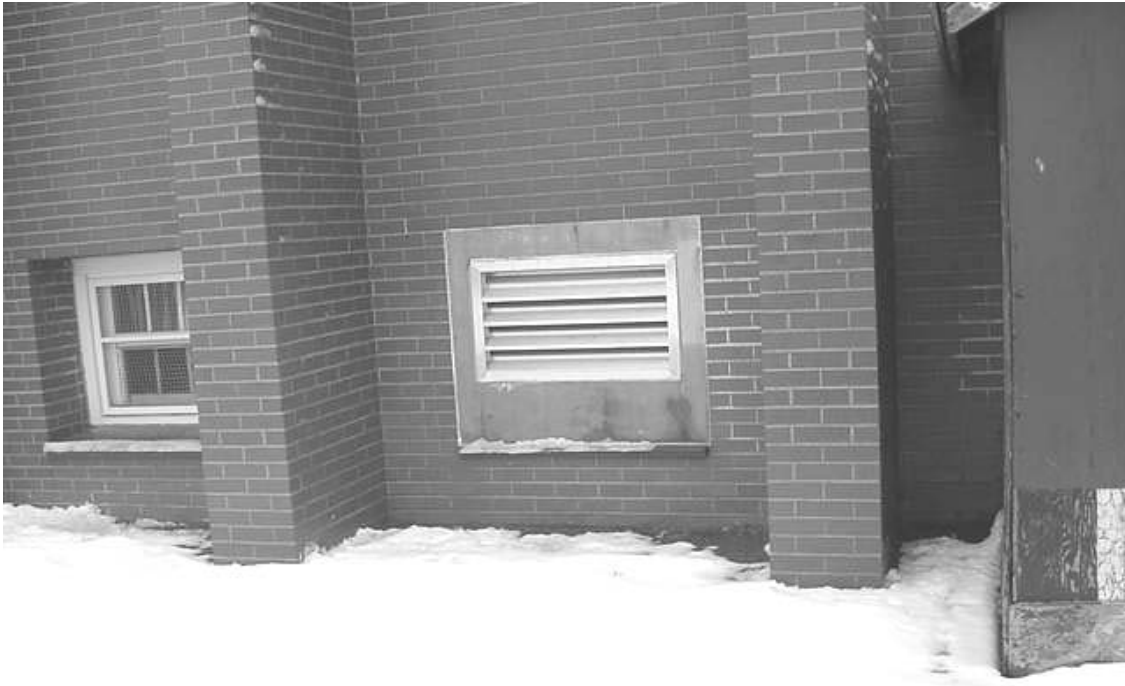
Picture 2

Univent Fresh Air Intake

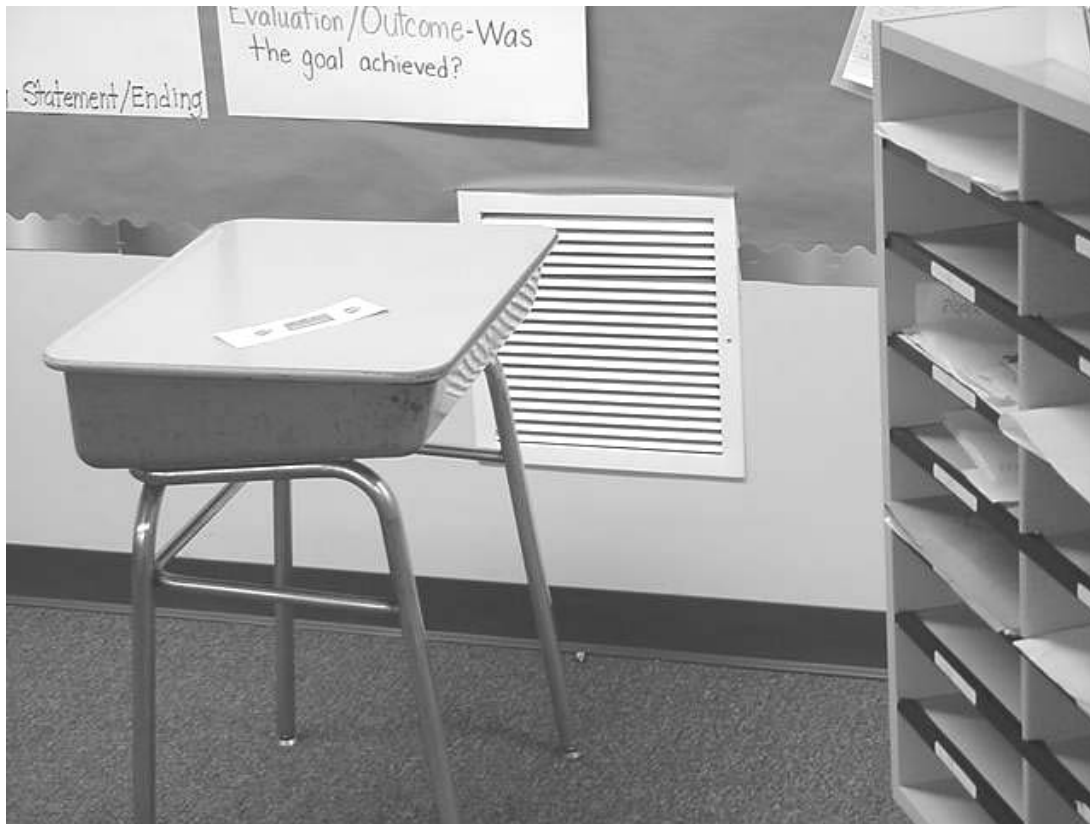
Picture 3

Wall-Mounted Exhaust Vent in Basement Classroom

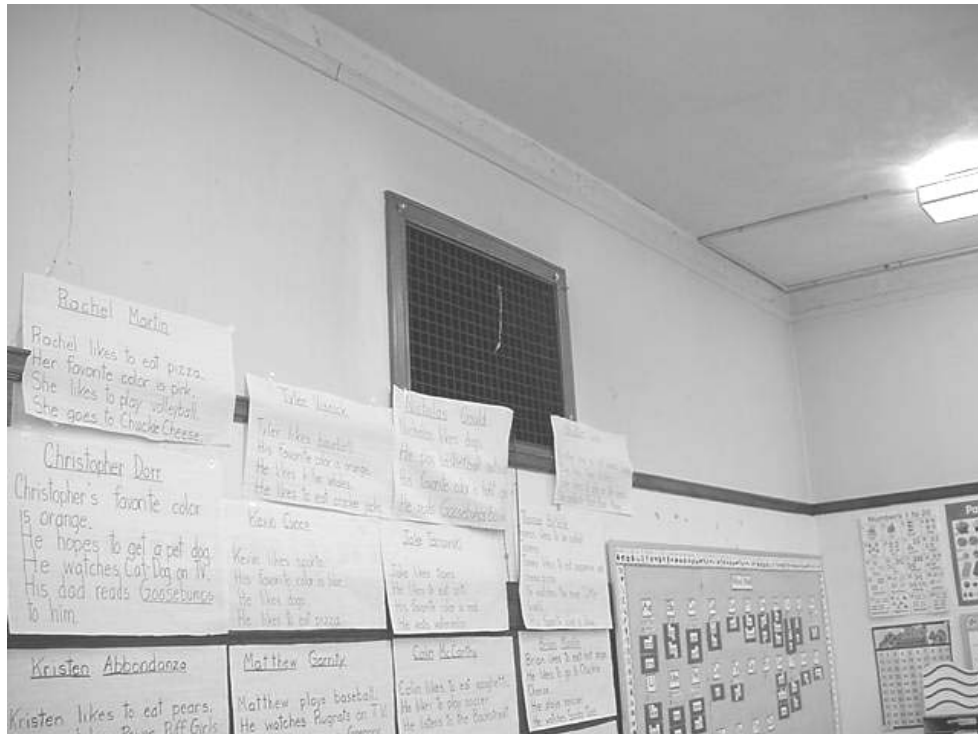
Picture 4

Abandoned Classroom Supply Vent

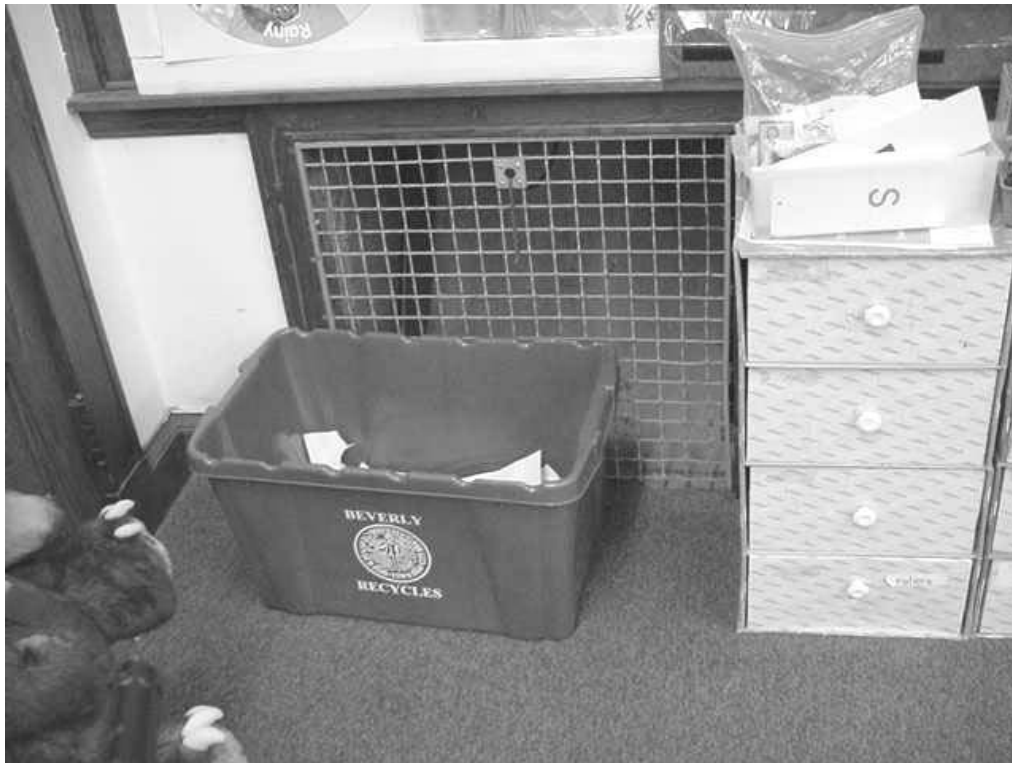
Picture 5

Abandoned Classroom Exhaust Vent

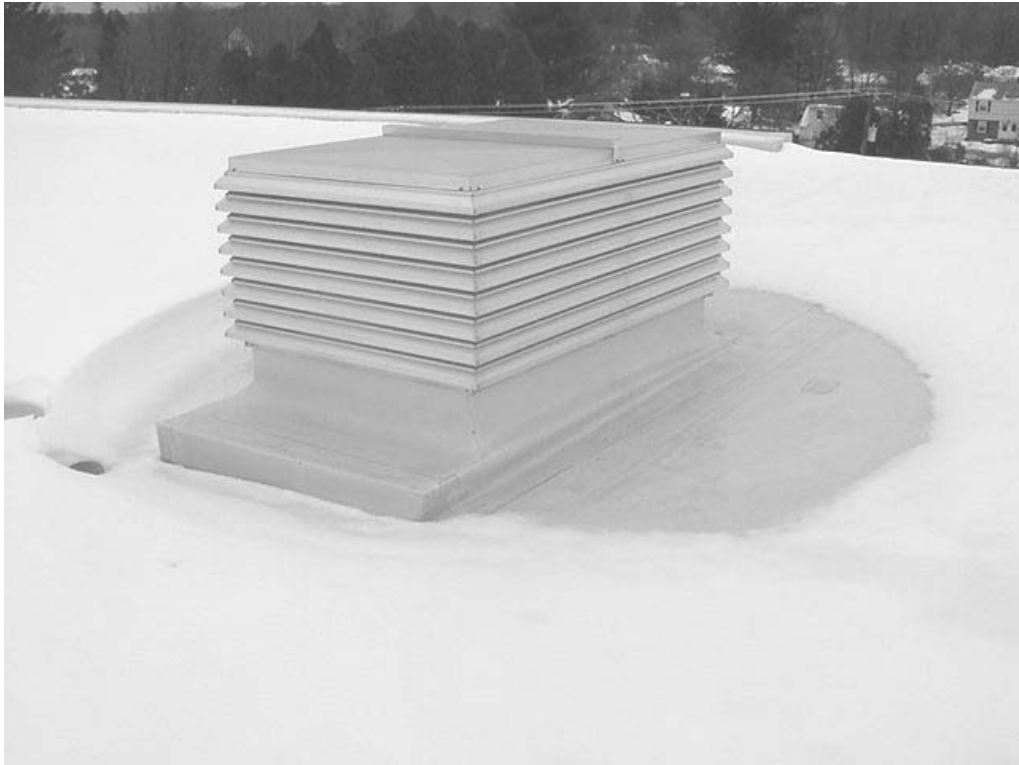
Picture 6

Louvered Chimney Cap, Note Melted Snow Due to Escaping Classroom Heat

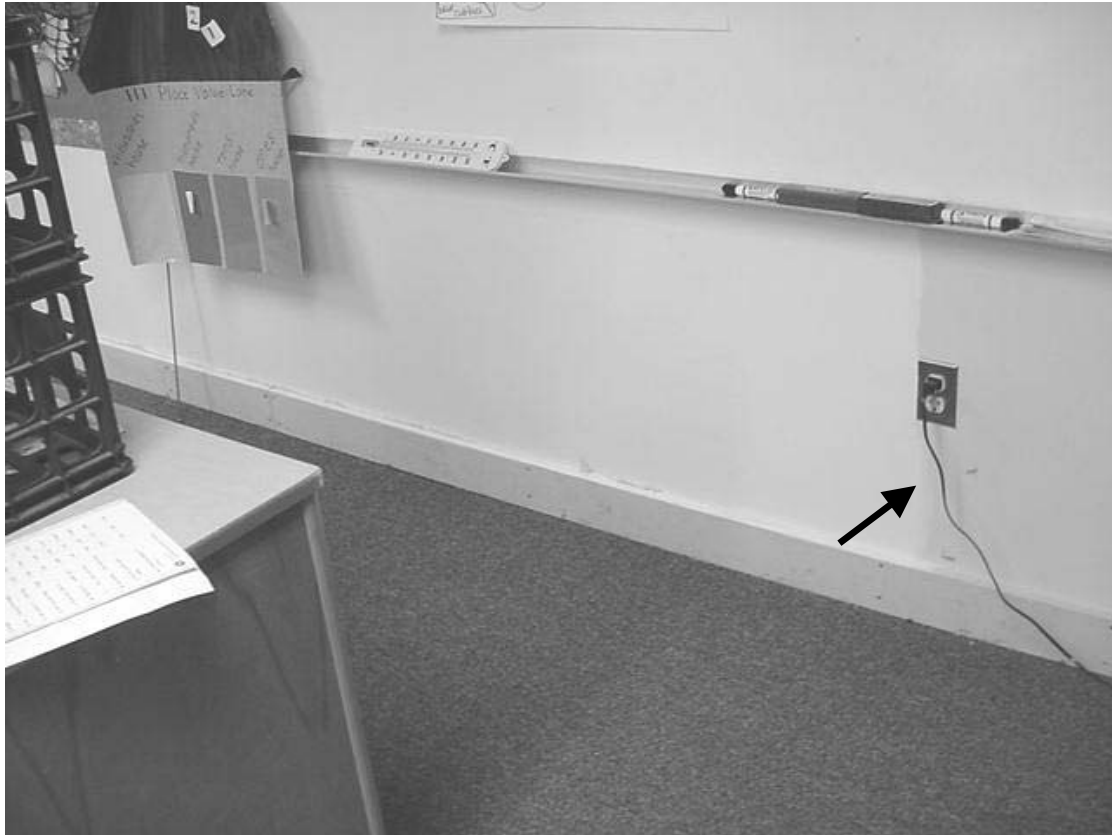
Picture 7

A number of moisture measurements were taken of GW at varying heights (i.e. three feet, two feet, and six inches above the floor respectively). No elevated moisture measurements were recorded. Visual inspection of classrooms 2-O & 2-M suggested no obvious water damage on walls, ceilings or carpeting. These results indicate that the GW is not moistened at the time of this assessment and that further microbial growth would be limited due to a lack of water.

Dividing Wall between Basement Classrooms 2-O & 2-M, Note Lined Delineating New Section of GW

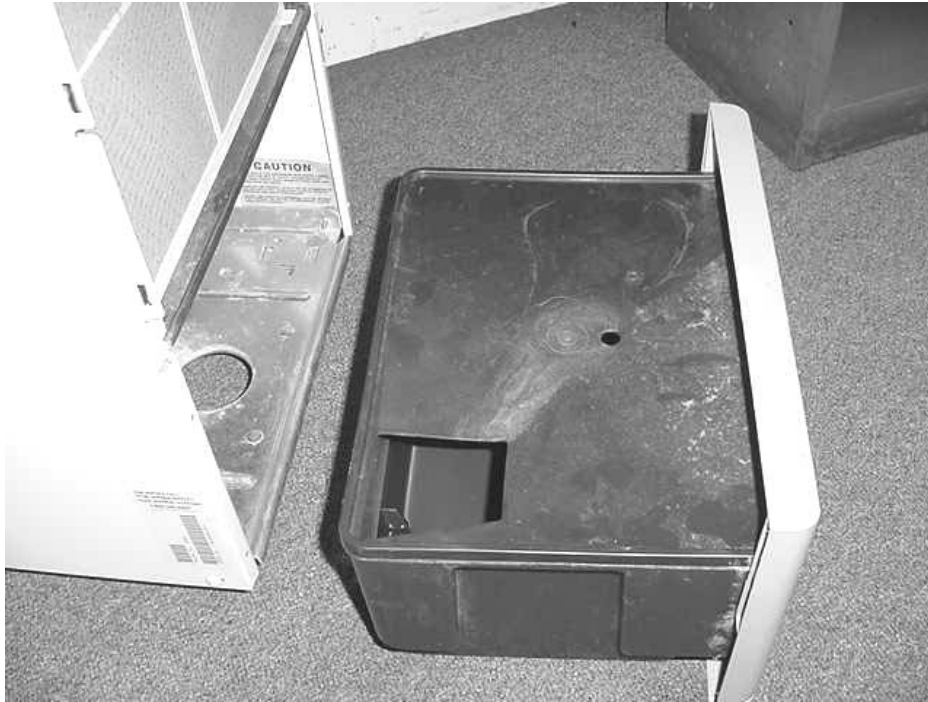
Picture 8

Other potential sources of microbial growth and associated odors were also observed. Musty, mold-like odors were detected in the band room. The band room had several dehumidifiers that had reportedly not been in use since autumn, containing standing water (see Picture 8). Water damaged ceiling tiles were also observed, near plumbing fixtures which can indicate current or historic leaks from the plumbing system. Water-damaged ceiling tiles can provide a source of mold and should be replaced after a water leak is discovered.

One of Several Dehumidifiers in the Basement Band Room Containing Standing Water

18. Clean/change filters for dehumidifiers and air-handling equipment as per the manufacturer's instructions or more frequently if needed. Vacuum interior of units prior to activation to prevent the aerosolization of dirt, dust and particulates. Ensure filters fit flush in their racks with no spaces in between allowing bypass of unfiltered air into the unit.

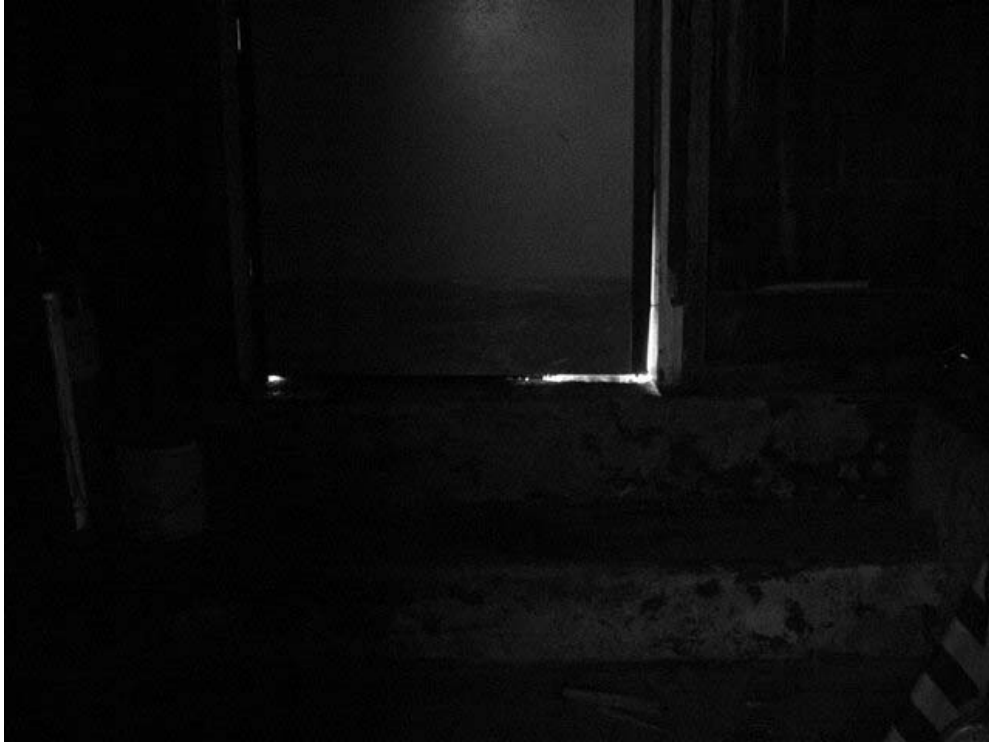
Picture 9

A number of means exist for uncontrolled airborne moisture and rainwater to penetrate into the basement. Spaces around exterior doors were observed in several areas in the basement (see Pictures 9). Spaces around exterior doors can allow a means of water penetration into the building, subsequently wetting building materials. The wooden doors themselves showed signs of repeated water damage (see Picture 10). In some cases carpeting is installed directly inside these areas (see Picture 10). Carpeting in the band room had a number of water stains that indicated previous water damage.

Light Penetration around Basement Classroom Exterior Door

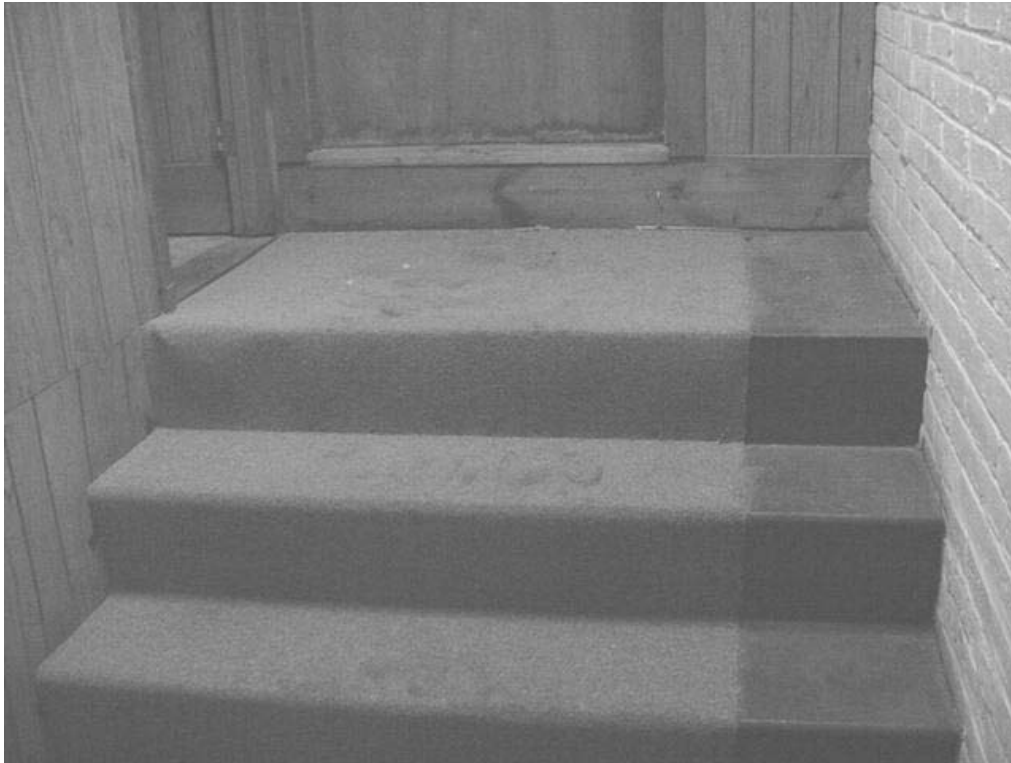
Picture 10

**Carpeting Installed on Stairs near Basement Exterior Door, Note Water Damage
along Bottom of Wooden Door**

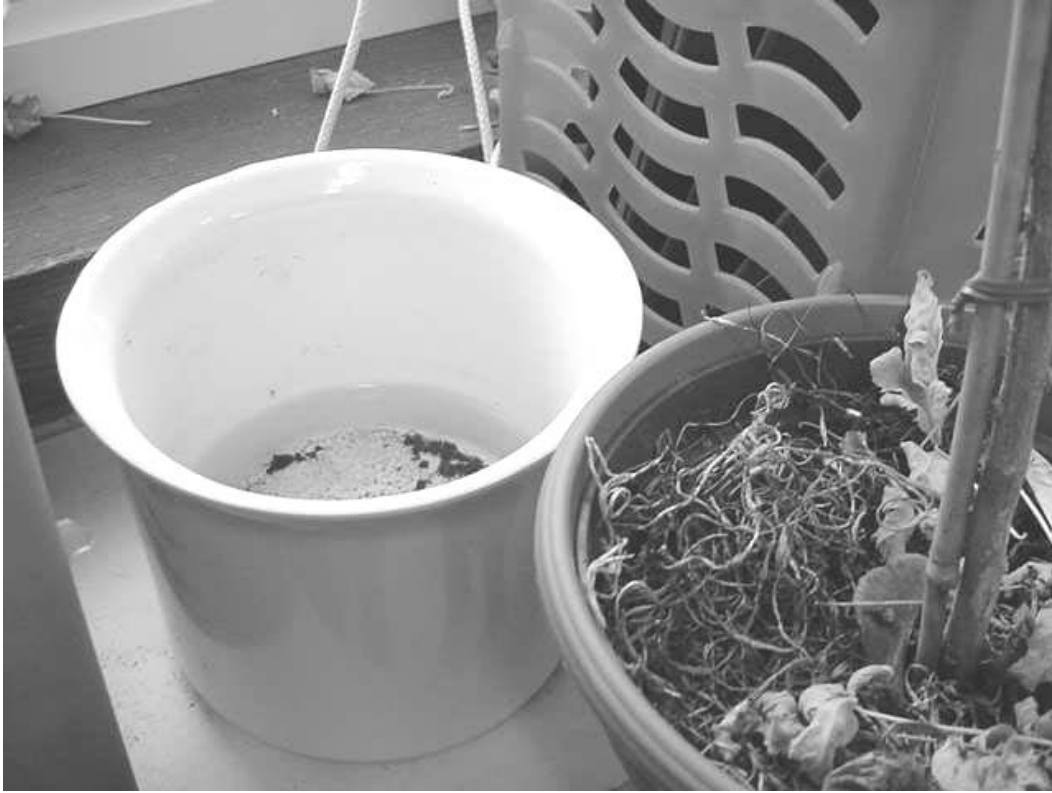
Picture 11

Several classrooms contained a number of plants. Plant soil and drip pans can serve as a source of mold growth. Plants and potting soil were found on top of univents in several classrooms. Some plants were noted in standing water (see Picture 11). Plants should be properly maintained and be equipped with drip pans. Plants should also be located away from air diffusers to prevent aerosolization of dirt, pollen or mold. Picture 12 shows a classroom

Plant in Standing Water in Classroom

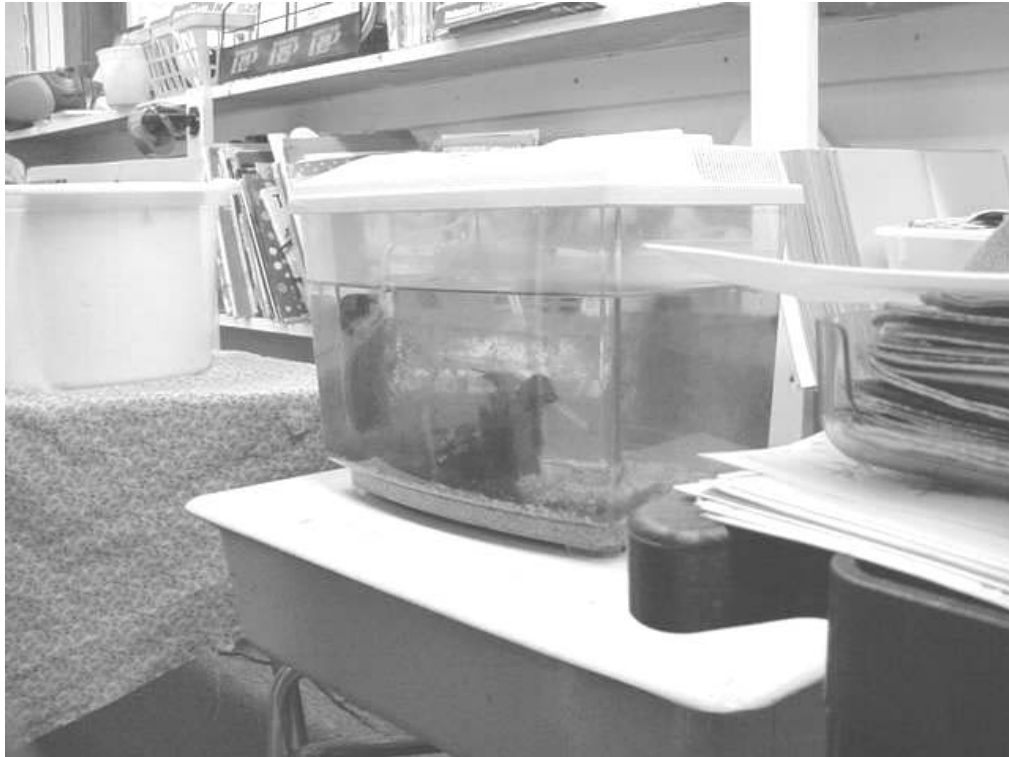
Picture 12

aquarium that was green with microbial growth. Aquariums should be properly maintained as to not grow mold and or provide a source of unpleasant odors.

Classroom Aquarium Green With Microbial Growth

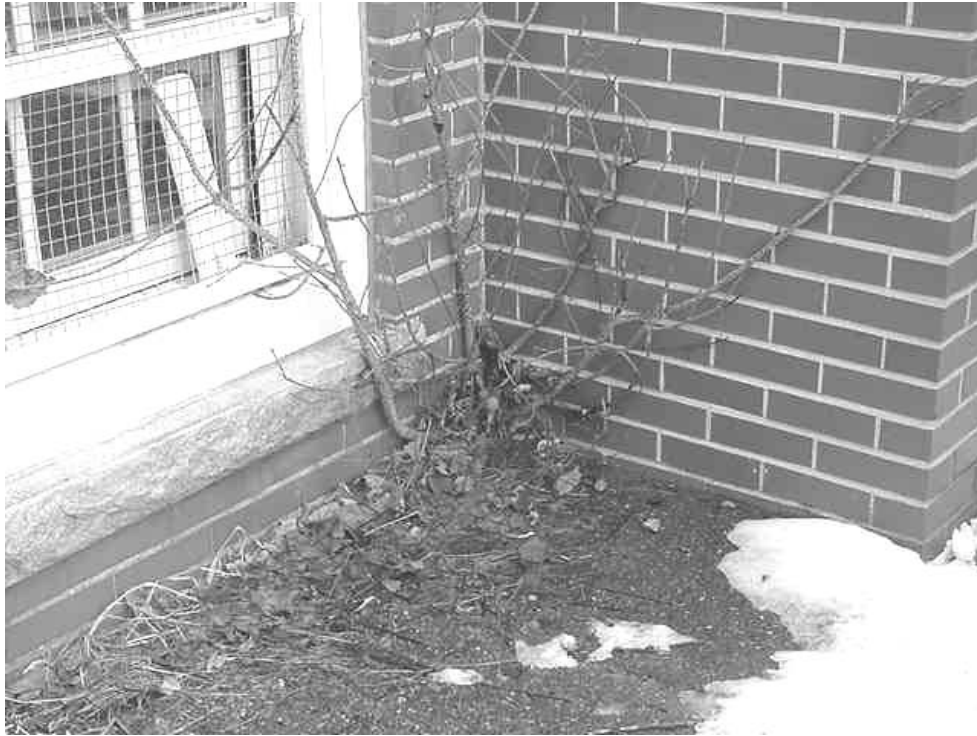
Picture 13

Different means for water to have prolonged contact with the foundation wall exist around the perimeter of the building. Small trees and other plants were also seen growing in the tarmac/exterior wall junction (see Picture 13). The growth of roots against the exterior of foundation walls, as well as spaces between the tarmac, can bring moisture in contact with brick and foundation structures, which may eventually lead to moisture penetration below ground level areas of the building. Over time, this process can undermine the integrity of the building envelope and provide a means of water entry into the building through capillary action through foundation concrete and masonry (Lstiburek, J. & Brennan, T.; 2001). Once through the foundation wall, the installation of paneling serves to prevent moisture evaporation, potentially moistening of wall materials and wall to wall carpet.

Trees/Roots Growing against the Building

13. Remove plant growing against the exterior wall/foundation of the building to prevent water penetration.
14. Replace missing ceiling tiles and fill utility holes in classrooms (e.g. around radiator pipes), to prevent the egress of odors, dust and particulate matter between areas.

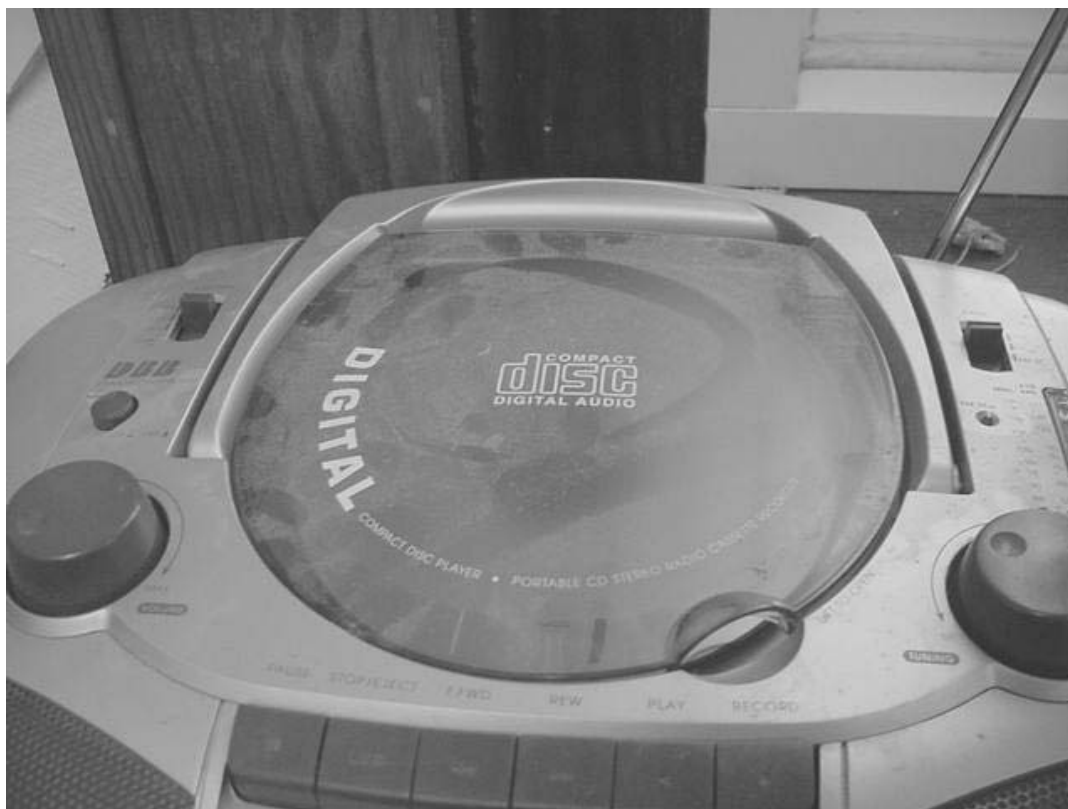
Picture 14

Also of note was the amount of materials stored inside classrooms. In classrooms throughout the school, items were observed on windowsills, tabletops, counters, bookcases and desks. The large number of items stored in classrooms provide a source for dusts to accumulate (see Picture 14). These items (e.g., papers, folders, boxes, etc.) also make it difficult for custodial staff to clean. Dust can be irritating to eyes, nose and respiratory tract. Items should be relocated and/or be cleaned periodically to avoid excessive dust build up.

Accumulated Dust on Radio in Classroom

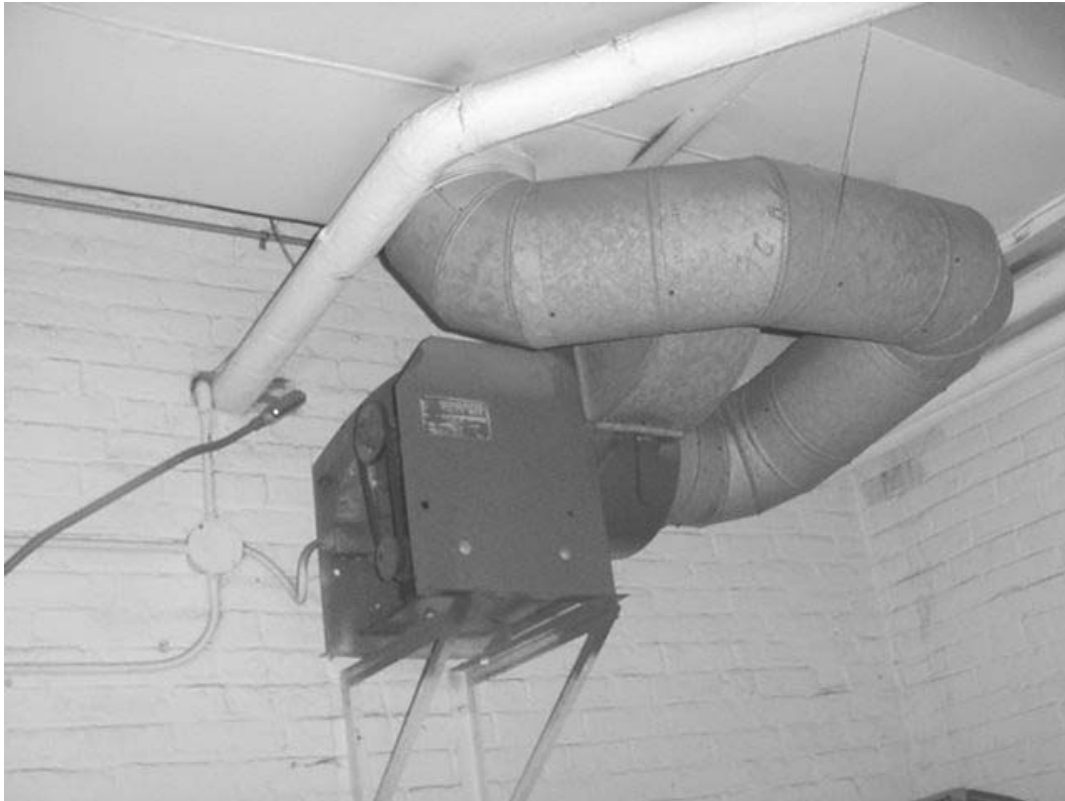
Picture 15

Several other conditions were noted during the assessment, which can affect indoor air quality. A pottery kiln equipped with local exhaust ventilation is located in a small room in the basement. The exhaust ductwork however appears to be tied in with the general exhaust for the girl’s restroom. Pottery kilns can produce carbon monoxide and sulfur dioxide, which can cause respiratory symptoms in exposed individuals (McCann, M., 1985). The configuration of the kiln exhaust presents the opportunity for kiln emissions to enter occupied areas if the general exhaust is not activated. The kiln should be vented directly outside, not connected to the general exhaust. In addition, the ductwork connecting the exhaust motor to the duct contains a number of turns (see Picture 15). Airflow is decreased roughly in half by every 90° angle that exists in ductwork. This ductwork appears to contain over 320° of angles. If the draw of fresh air by the exhaust fan were 100 percent, the angles of this ductwork would reduce that draw to less than 10 percent.

Basement Kiln Vent, Note Configuration of Ductwork

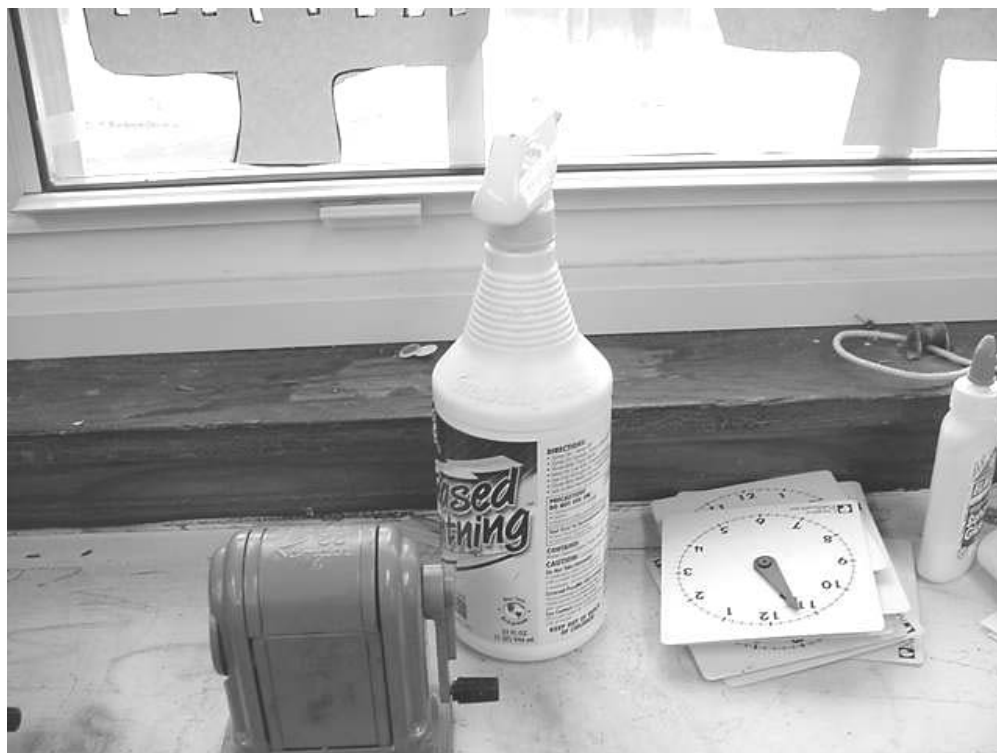
Picture 16

Cleaning products and other chemicals were found in floor level cabinets and on counter tops in several classrooms (see Picture 16). Cleaning products contain chemicals (such as bleach or ammonia-related compounds), which can be irritating to the eyes, nose and throat. These items should be stored properly and out of the reach of students.

Spray Bottle of Degreaser in Classroom

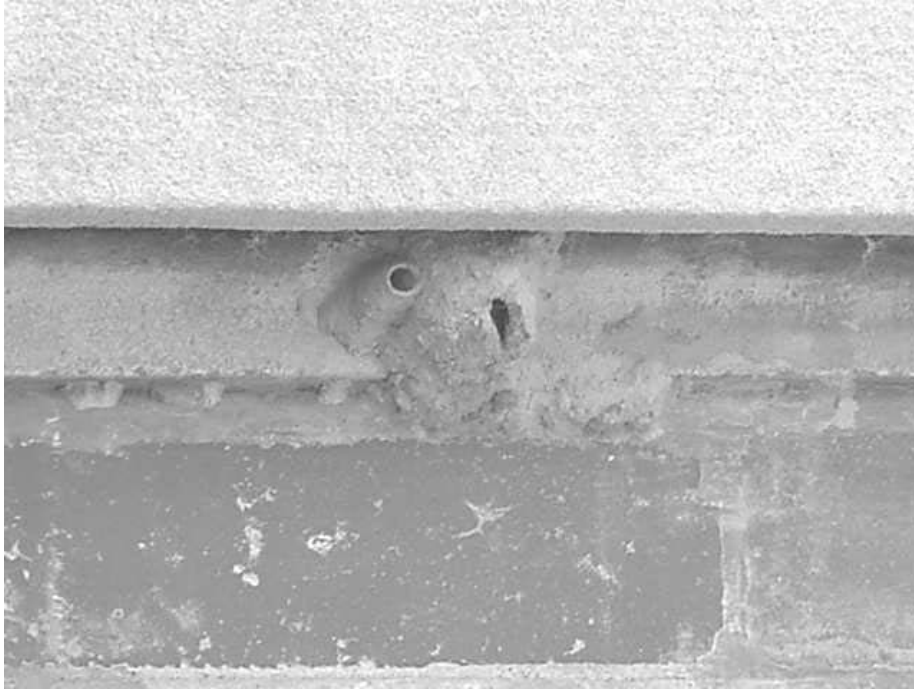
Picture 17

A number of wasp's nests were observed along the perimeter of the building (see Picture 17). Under current Massachusetts law that, effective November 1, 2001, the principles of integrated pest management (IPM) must be used to remove pests in state buildings and grounds (Mass Act, 2000).

Wasp's Nests along Perimeter of Building (Side Door Parking Lot)

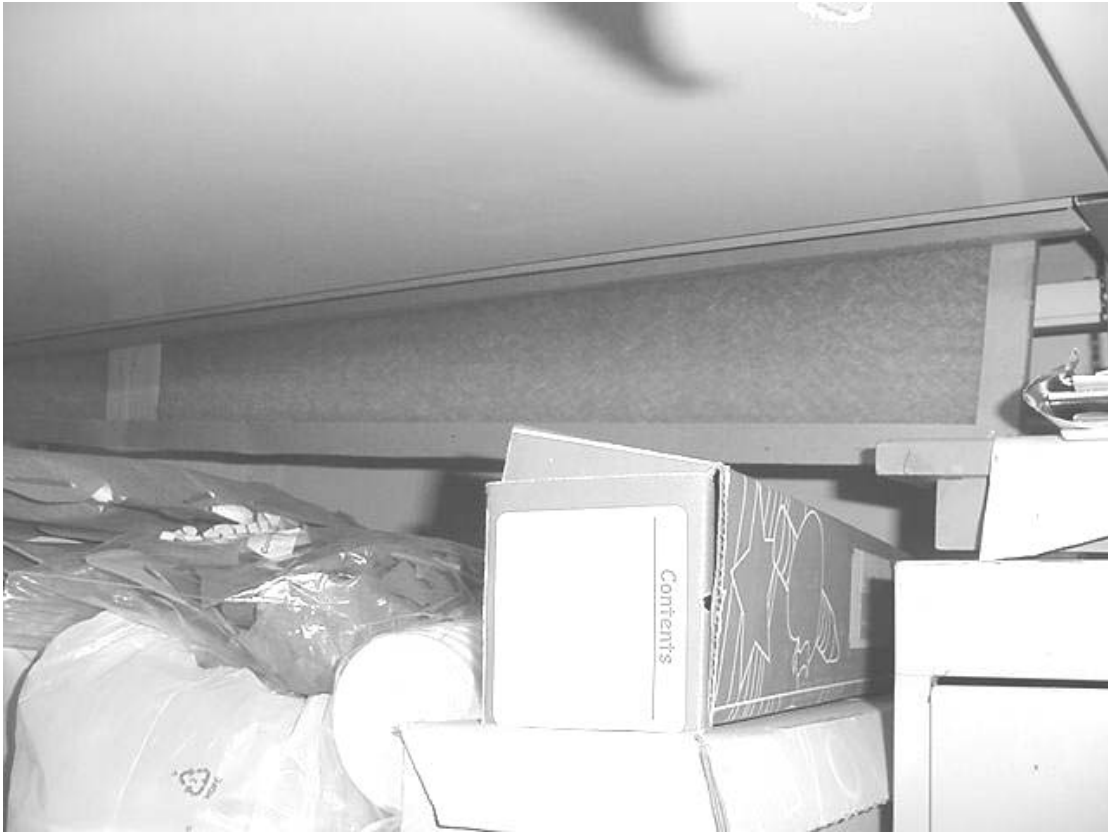
Picture 18

Univent Filters in Classroom 2-M
